# Manhole Inspection Summary

Manhole # S03CC2021MH

**Location** Address: **3001 BENHURST RD**

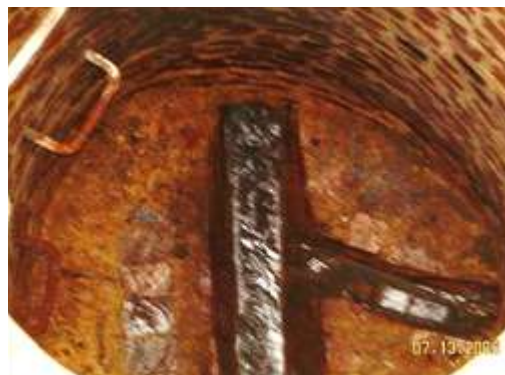
Top View

Adjustment and Barrel infiltration.  
Corroded steps. Bench debris.

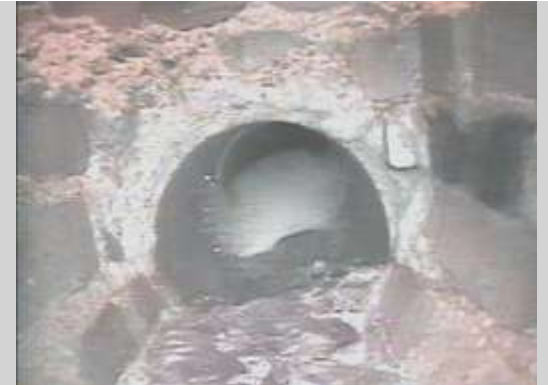
### 8 in. Circular Gravity Sewer Pipe Out @ 12 O'Clock

Infiltration: **Evidence** Pipe Seal Cond: **Unknown**

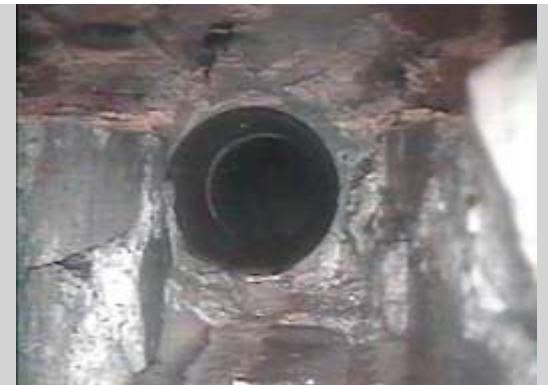
### 6 in. Circular Gravity Sewer Pipe In @ 3 O'Clock

Channel deterioration.

Infiltration: **Evidence** Pipe Seal Cond: **Unknown**

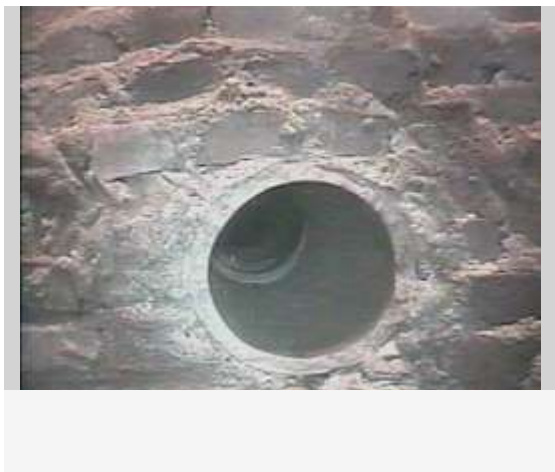
Pipe In @ 6 O'Clock

Infiltration: **Evidence** Pipe Seal Cond: **Unknown**

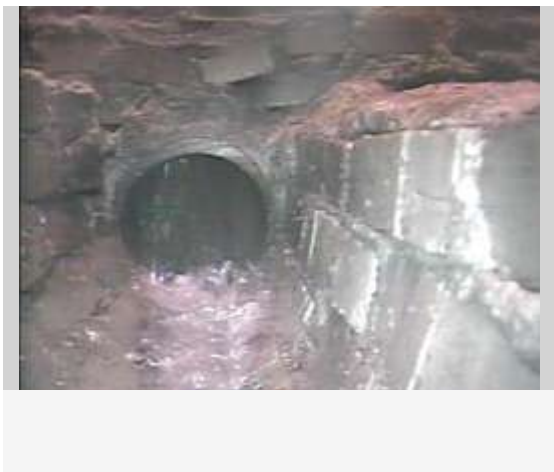
Drop In @ 6 O'Clock

Drop: <b>Outside</b>	Rod and Bar
Angled: <b>Yes</b>	Reading: <b>10.66</b> (ft.)
	Inv Depth: <b>11.66</b> (ft.)
Drop Condition: <b>Open</b>	
Connects To: <b>Manhole</b>	
<input type="checkbox"/> Possible Illicit Connection
